**National Highway
Traffic Safety
Administration**

DYNAMIC SCIENCE, INC.
In-Depth Accident Investigation

Contract DTNH22-94-D-27058
Case DSI-94-AB-016

TECHNICAL SUMMARY

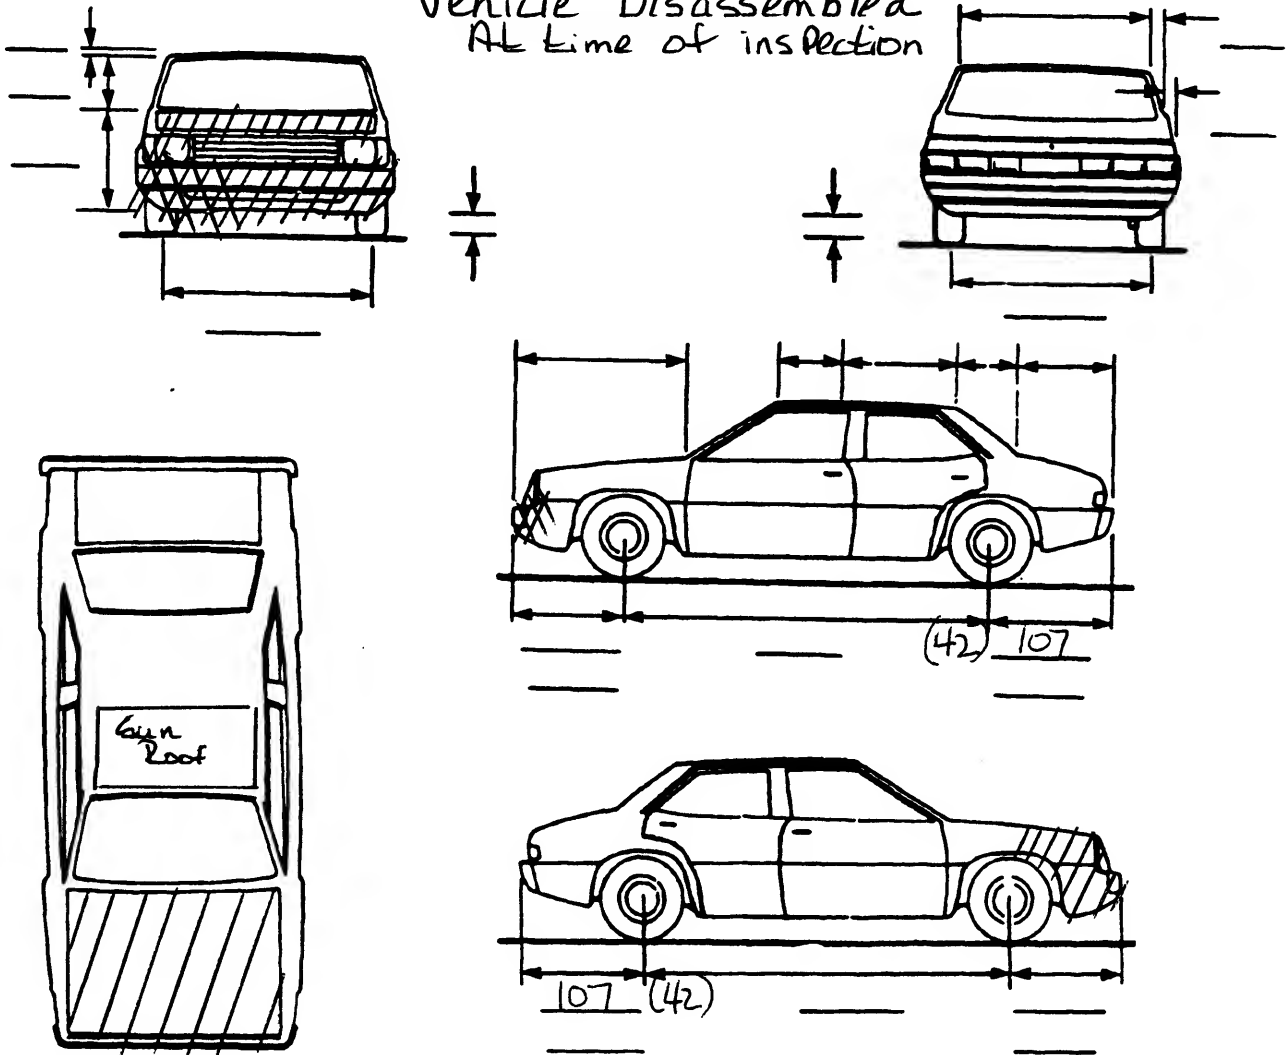
VEHICLE DAMAGE SKETCH

Specific Impact Number	Plane of Impact C-Measurements	Direct Damage		Field L	C ₁	C ₂	C ₃	C ₄	C ₅	C ₆	± D
		Width (CDC)	Max Crush								
1	Front Rt	62.9	Zone 1	CDC Data only							
2	Front left	21.6	Zone 1	-CDC Data Only.

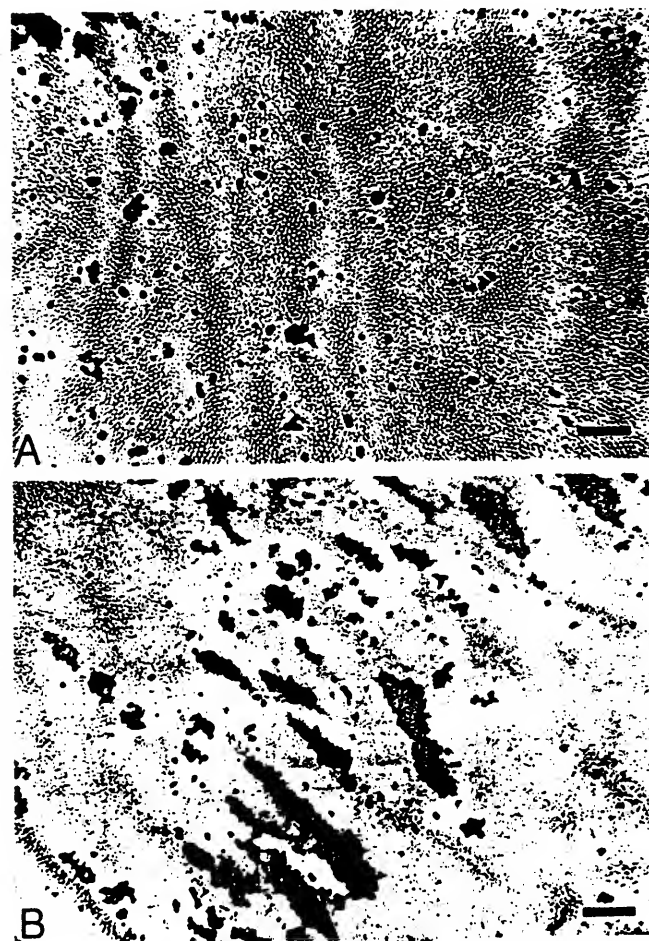
Figure 4. The damaged endothelium after air bag impact (bar = 300 μ m). A, type C, 240 mm. Scattered areas staining with alizarin red were observed. B, type A, 240 mm. Areas of widespread staining with alizarin red, indicating detachment of Descemet's membrane or endothelial loss, were observed. Endothelial cell staining with trypan blue indicates damage to the cellular membranes.

Examples of damaged endothelium after air bag deployment for type C at 240 mm and type A at 240 mm are shown in Figures 4A and 4B, respectively. Widespread staining with alizarin red, indicating detachment of Descemet's membrane or endothelial loss, was observed. Considerable endothelial cell staining with trypan blue, indicating cellular membrane damage, also was observed.

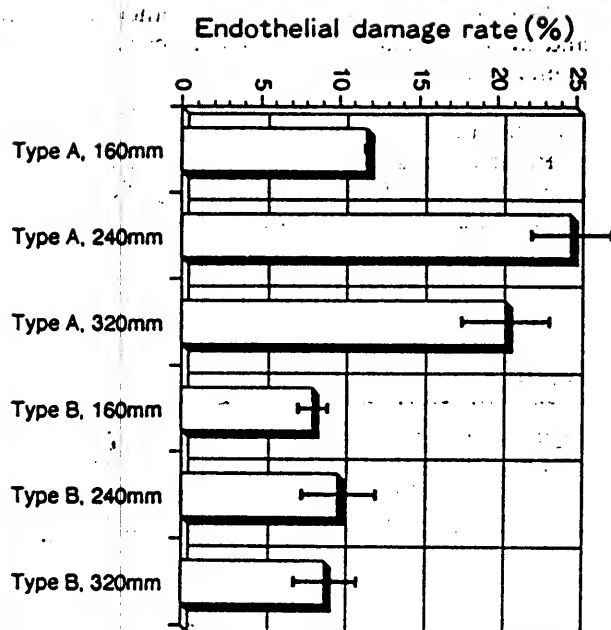
Figure 5. The endothelial damage rate for types A and B air bags at different distances.

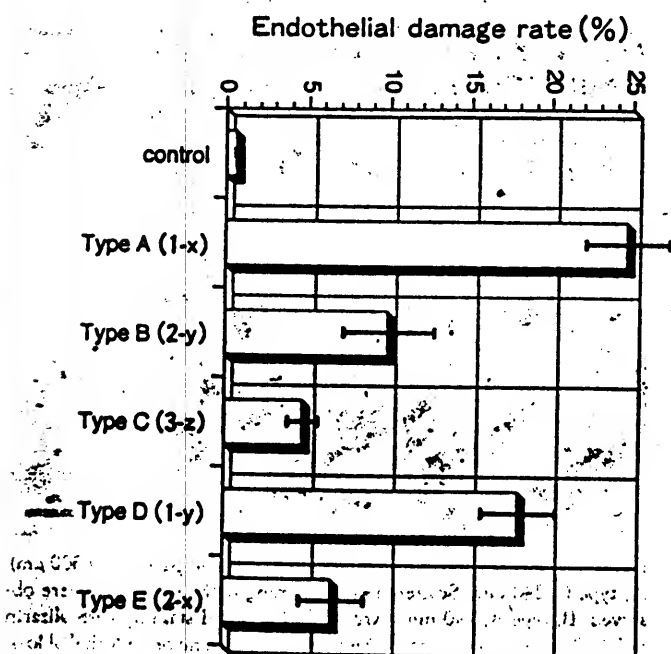
Figure 6. The endothelial damage rates for types A to E air bags at 240 mm.

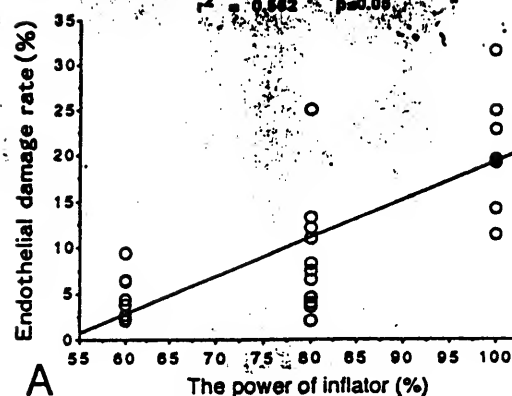
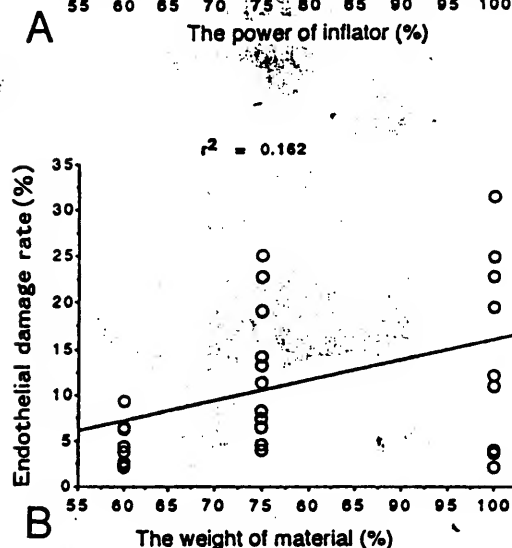
Figure 7. The correlation between (A) endothelial damage rate and the power of inflators (a, $r^2 = 0.56$, $P < 0.05$) and (B) the weight of the bag materials ($r^2 = 0.16$).
